SHANGHAI'S EXPERIENCE ON UTILIZING THE RUBBLIZATION FOR JOINTED CONCRETE PAVEMENT REHABILITATION

Dar-Hao Chen¹, Qinlong Huang², and Jianming Ling³

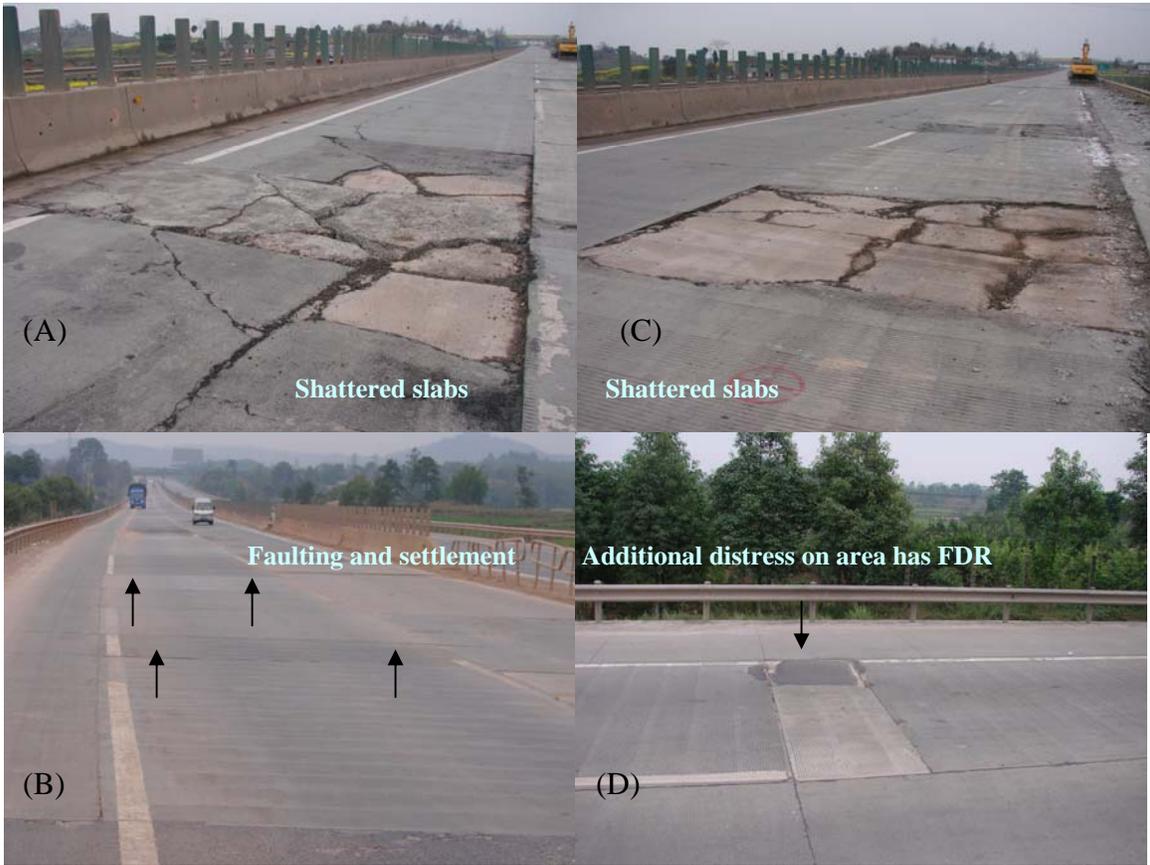
Fig. 2 Severe Distresses Including (A &B) Shattered Slabs, (C) Faulting/ Settlement (D) Additional Distress Reappeared on Area where received Full Depth Repair (FDR)

The condition survey indicated that there were many severe longitudinal cracks, settlements, and shattered slabs on Huchinping highway. The shattered slabs have been determined to be more than 10%. With increasing annual maintenance spending but no improvement on pavement condition, SMRA was studying different alternatives. In addition to rubblization, two other alternatives in consideration to rehab severely deteriorated JCP were (1) to remove the JCP and to reconstruct the pavement section (2) to conduct full depth repair, to underseal voids with pressure grout, and then to overlay with hotmix asphalt concrete (HMAC). However, the initial construction costs and user delays make the alternative 1 impossible and there are significant risks for reflective cracking for alternative 2. Furthermore, there are many local businesses and residents along the Huchinping highway with underground utilities. The closest building to the Huchinping highway is only 15m. To minimize the disturbances (noise and vibration) to the local residents, resonant breaker was selected by the SMRA to rubblize the Huchinping highway. It was thought that the resonant breaker would yield minimum

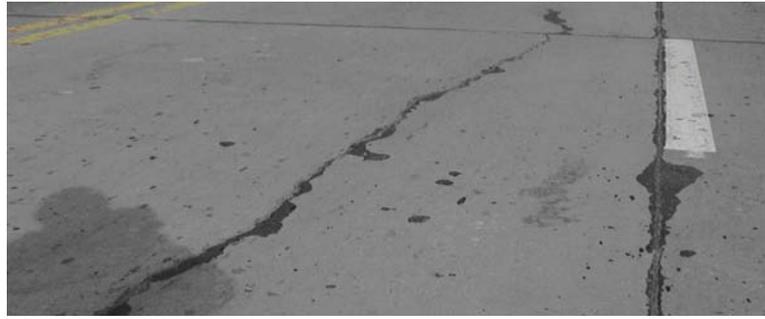
Fig. 3 Before Rubblization Pavement Condition and the Geometric for the Huchinping Highway

Huchinping highway was widened and reconstructed between 1990 and 1993 from original 7m two lanes roadway to 28.4m four traveling lanes plus two slow moving lanes, as shown in Fig. 3. The design speed for the four traveling lanes is 100km/h. The typical structure consists of 240mm concrete slab, 300mm fly ash treated base and 150mm river aggregate and sand mix subbase. Based on the 2002 traffic survey, the maximum daily traffic reached 23,613 vehicles per day. The estimated 15-year design traffic is 8.63 millions repetitions of 100-kN Axle load which is approximately 20.66 millions of 80-kN Equivalent Single Axle Load (ESAL).

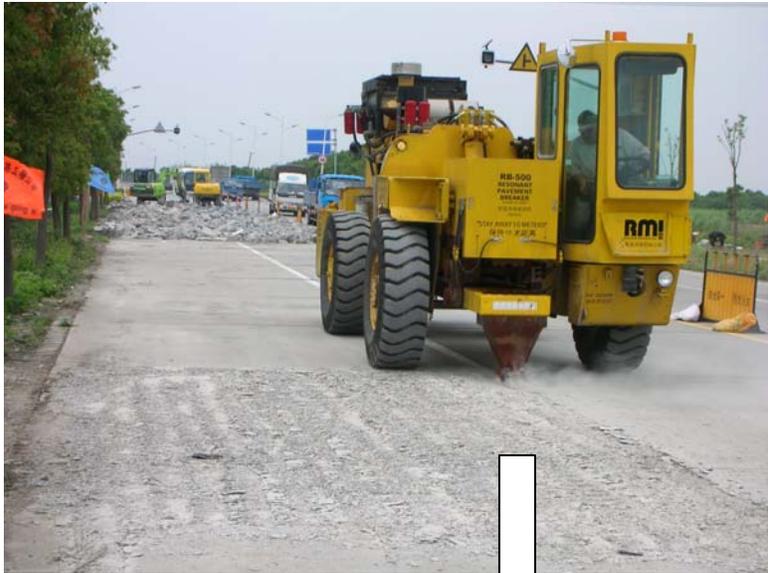
Fig. 4 Resonant Pavement Breaker and Illustration of PCC Fracturing Resulting from Resonant Rubblezation

The resonant breaker uses a 200 to 275 mm shoe located on the end of a pedestal that is connected to a beam with 5,450 to 9,100 kg (12,000 to 20,000 lbs) counter weight. It is operated under a low amplitude (<12.5 mm) high frequency (44 Hz) shoe to deliver energy to the slab that is near the harmonic frequency of PCC pavement. The low amplitude is to avoid disruption of base and prevent damage to underground structures (e.g. utilities), as shown in Fig. 4.

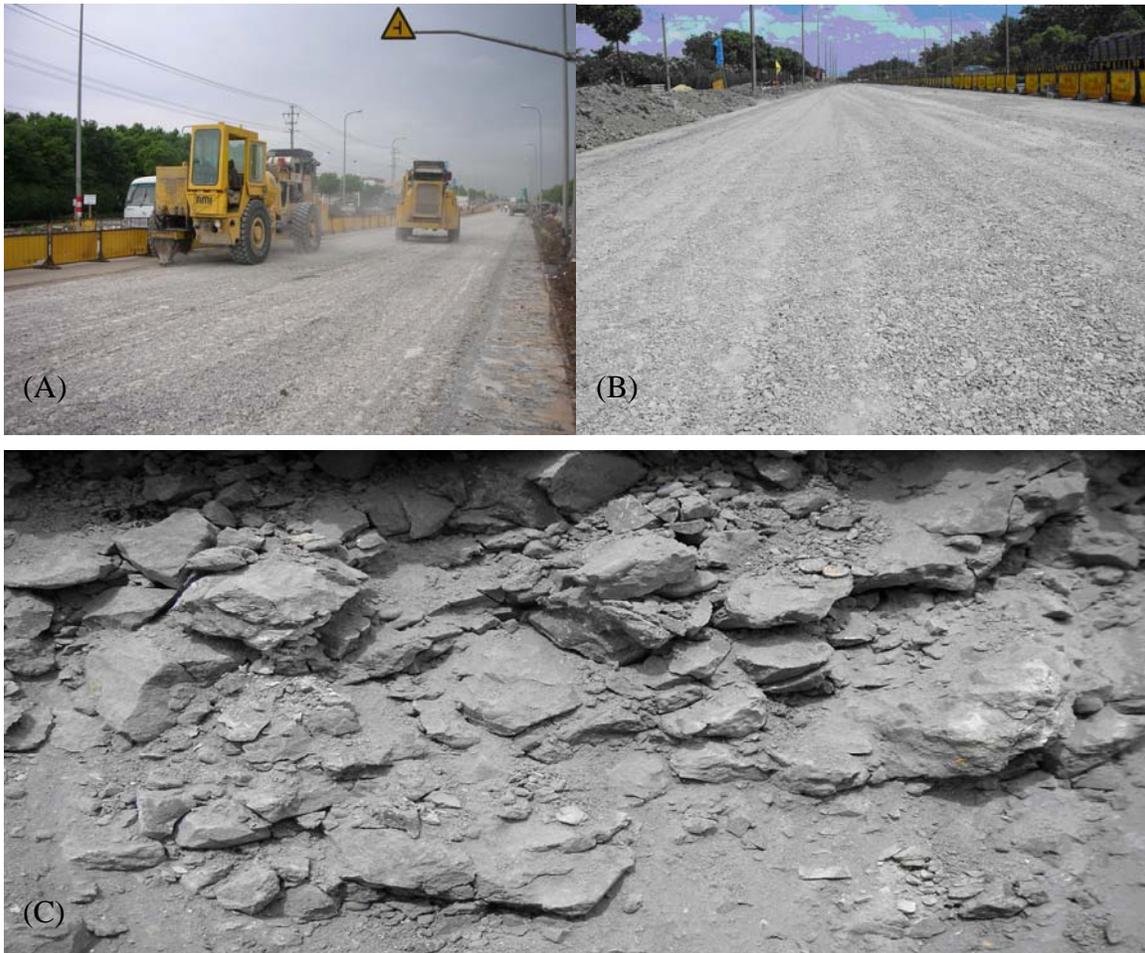
Fig. 5 Rubblization Using Resonant Breaker on Huchinping Highway (A) Two RMI RB500 Resonant Breaker in Action (B) Rubblized Surface Condition Before Rolling, and (C) Test Trench Show Fractured Particles Throughout Entire JCP Thickness.

Fig. 5 shows the rubblization using resonant breaker on Huchinping highway and the rubblized concrete surface condition. A 1m square test trench was dug after the rubblization to exam the particle sizes. That was conducted to calibrate the rubblization equipment to the existing site conditions. The test trench was also used to assure that the JCP had been fractured throughout its entire thickness. As shown in Fig. 5, the rubblization was very effective and it did rubblize the JCP throughout its entire thickness (240mm). Specimens were collected and the sieve analyses were performed. Only the samples at the top 50mm were collected due to the accessibility. The samples below 50mm were not collected because there was wire mesh in the concrete layer that prevents sample collection. It was found that the majority (~ 73%) of the particle sizes ranged from 2.5mm to 31.6mm. The most particle sizes were 5mm and 10mm that consists of 14.4% and 14.6%, respectively. All particles were less than 50mm. The gradation met the flexible base requirements, as shown in Table 2. As reported by Fitts [2006], the required particle sizes for most highway specifications are usually 150 mm nominal maximum size and 200 mm maximum particle size. If the rubblization process did not achieve these maximum particle size requirements, the contractor was required to repeat

Also, the observation from test trench indicated there were fractured slabs at the bottom of the rubblized JCP with 45 degree angle that provided better aggregate interlocked and load transfer. The observations from this study regarding the particle size and fractured slabs with 45 degree angles were consistent with those reported in the literatures [Fitts 2006]. For Huchinping Highway, vibratory rollers were utilized to compact the rubblized JCP with the main purpose to seat the particles. No traffic was allowed to prevent unseating the rubblized particles. Experience has shown that traffic should not be allowed on the rubblized surface until the minimum HMA thickness for the type of facility had been placed [Decker and Hansen 2006]. Although it was originally thought that the rolling should occur while the material was in a dry state, this had changed over time with experience. As with rolling any unbound material, moisture lubricates particle surfaces and facilitates particle reorientation [Fitts 2006]. Water was used during the compaction for Huchinping Highway to enhance the effectiveness of the compaction and dust control. Two passes of vibratory rollers were employed before the HMAC overlay. It was recommended by AI [2006] that the HMA overlay over a properly compacted rubblized PCC pavement should occur within a 48 hour period from the compaction process to prevent the rainfall water from entering the pavement system. The HMAC overlay was placed on Huchinping Highway on the same day after the compaction.

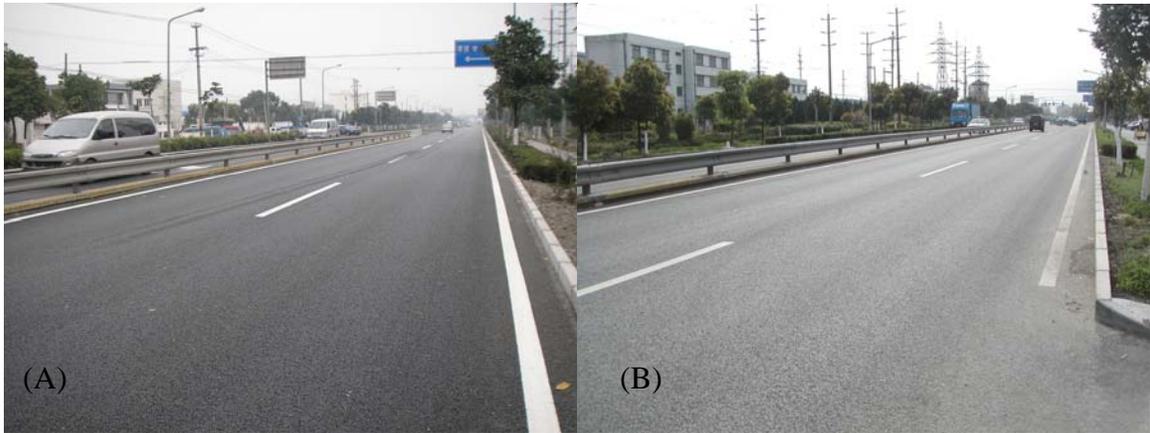
Fig. 6 Pavement Conditions for Huchinping Highway After (A) 1 Month and (B) 2 Years of Trafficking

The condition survey after more than 2 years of trafficking indicated that there was no visible distress and no variation among those 3 sections. Figs. 6A and 6B show the pavement conditions after 1 month and 2 years of trafficking, respectively. Based on field observation for typical a HMAC overlay on non-rubblized JCP, it was found that the treatment would normally have reflective cracking in first 3 years for the same overlay thickness.

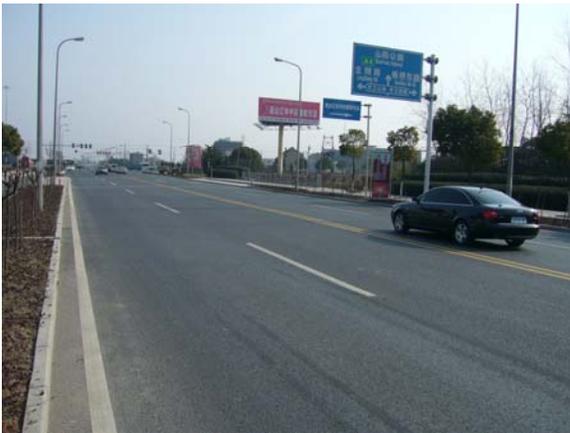
Fig. 9 Pavement Conditions for KimShan Broadway After 1 year of Trafficking

Fig. 9 shows the pavement condition after 1 years of trafficking. No visible distress could be observed and the performance has been satisfactory.
